Customer Service Bulletin SD800005

Cable Issues in SLF20050/C3 Antenna Couplers

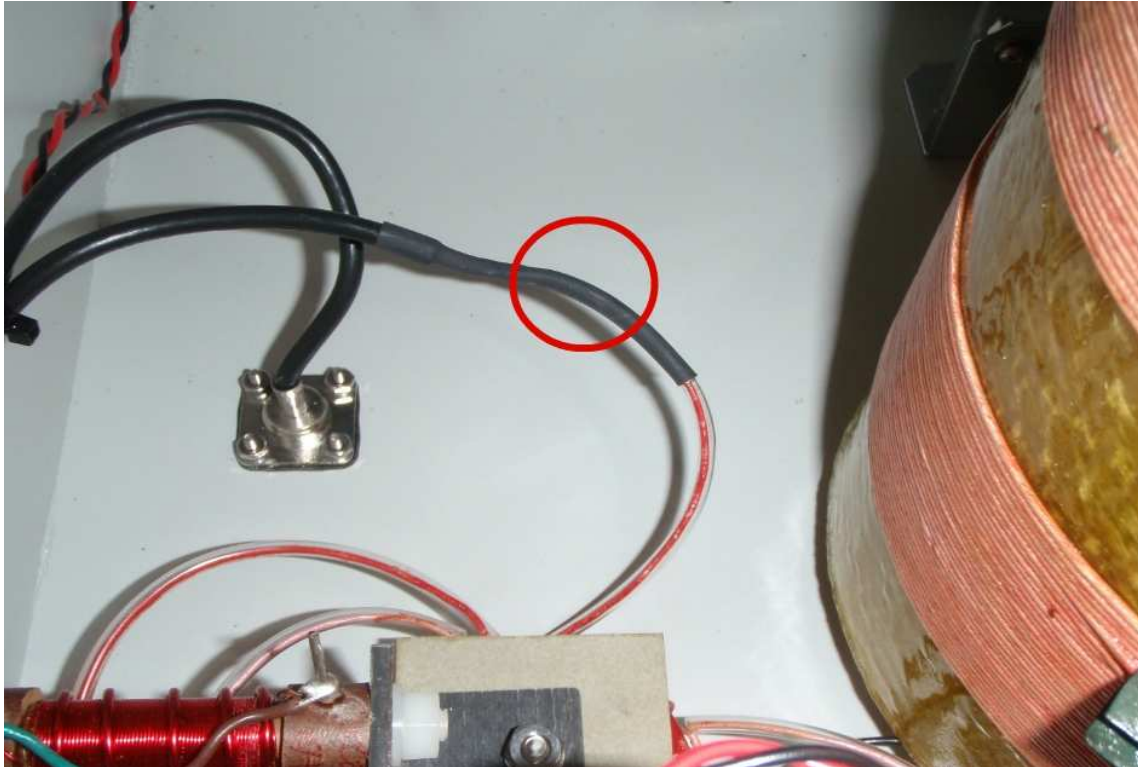
Remove heat shrink from this area

REMOVE SHIELD

WIRE 12:
STRIP OUTER JACKET BACK 2" AND
REMOVE SHIELD FROM STRIPPED SECTION.
SOLDER CENTER TO T1 PRIMARY FINISH
AND INSULATE WITH HEATSHRINK.

Verify shield is stripped fully per diagram.

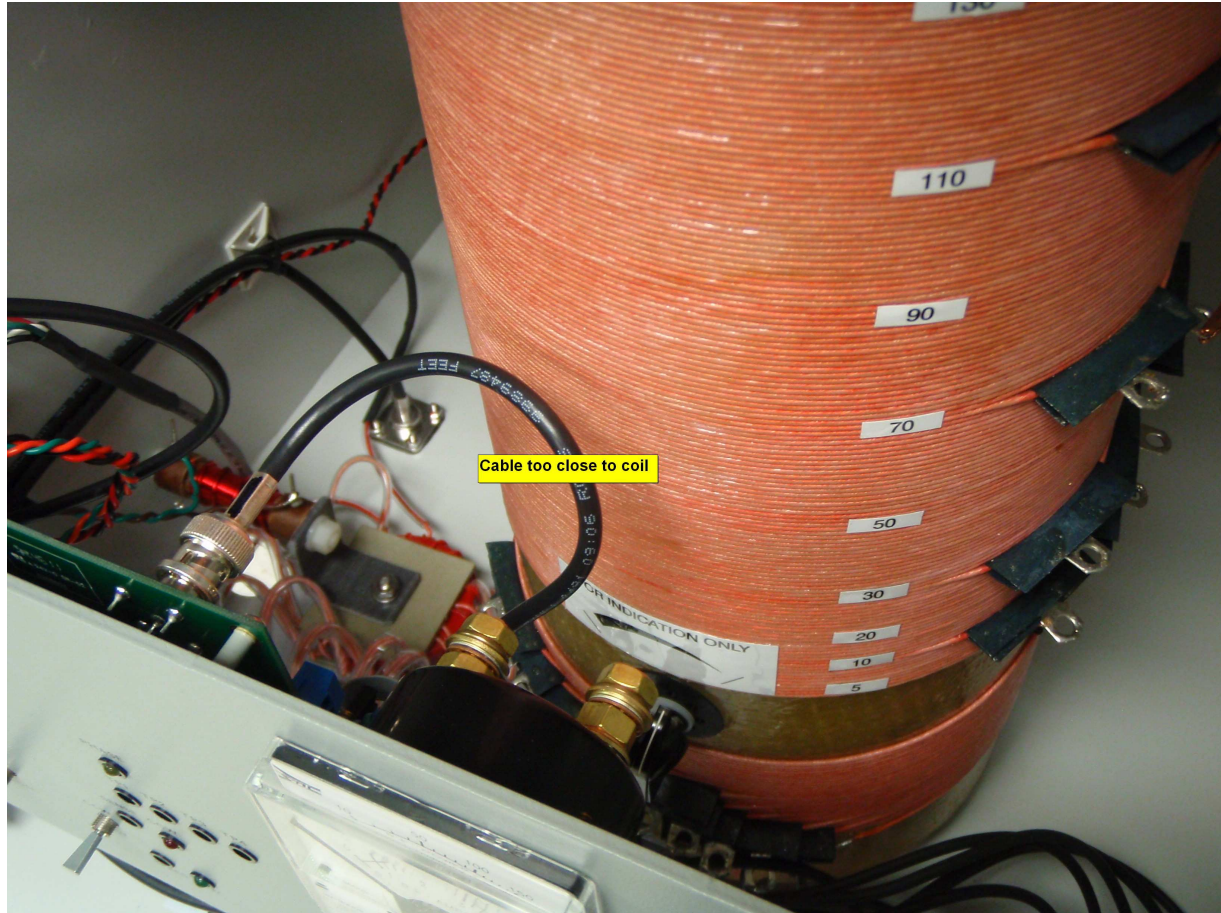
Cable too close to tuning coil.
