Customer Service Bulletin SD800007 Cable Issues in SE500 Rack Mount Transmitters

Application: This bulletin applies to **SE500 Rack Mount Transmitter SLF34002**. This applies to SE transmitters shipped prior to February 15, 2013.

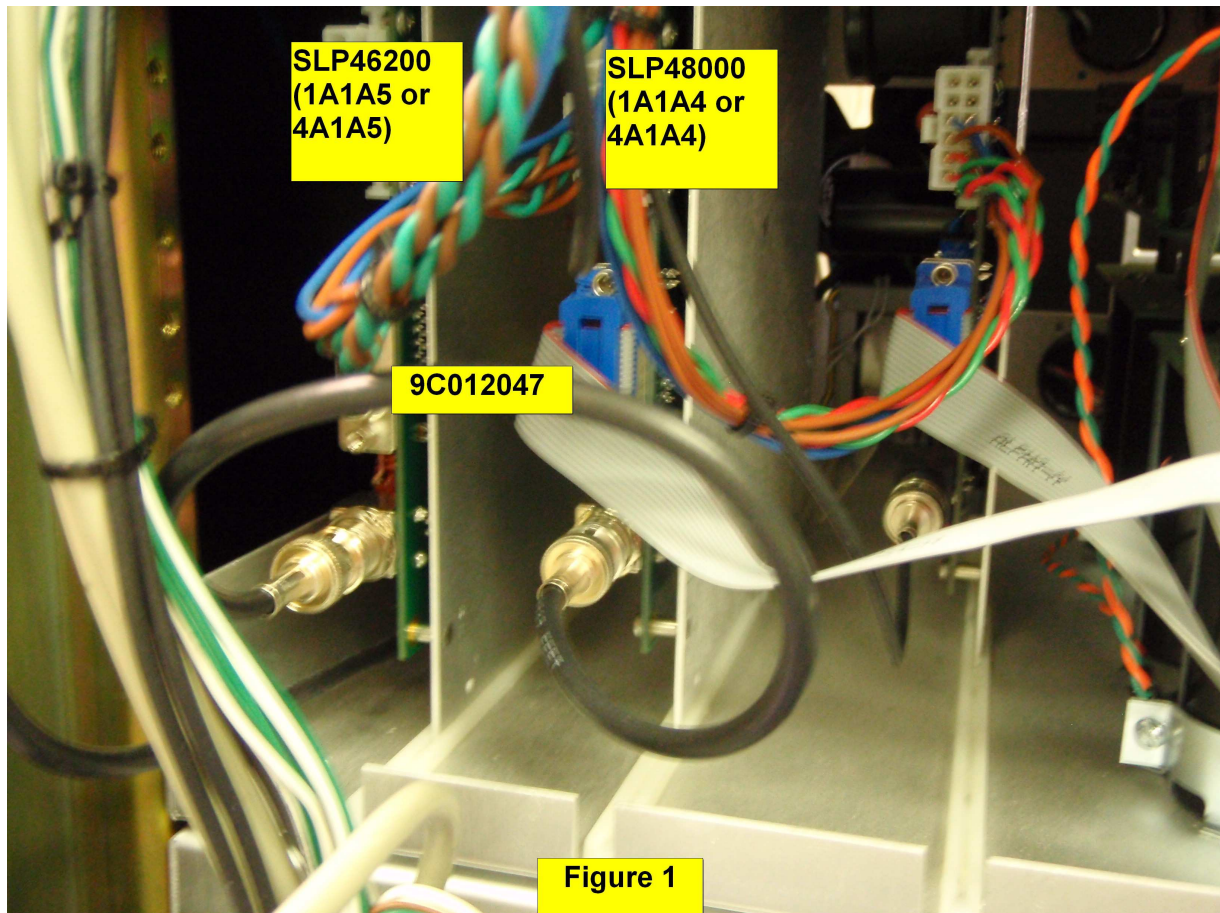
We have recently identified potential cable issues that could affect proper operation of the SE 500 transmitters. Due to high failure rates, we have invested in more reliable cables for all SE series transmitters.

- Disconnect the 9C012047 cable from J1 on the SLE46200 Filter Bridge Module 1A1A5, located on the left-hand side of the upper transmitter unit per Figure 1.
- Disconnect the other end of the 9C012047 cable from J2 the SLE48000 SPA Module 1A1A4, located on the left-hand side of the upper transmitter unit per Figure 1.
- Repeat the above steps on the SLE46200 Filter Bridge Module 4A1A5 and SLE48000 SPA Module 4A1A4 located on the left-hand side of the lower transmitter unit per Figure 1.
- Install replacement cables 9C012065 in place of the two (2) cables removed.
